Bonifica di materiali contenenti amianto presenti nelle coperture e nei fabbricati delle strutture universitarie facenti parte dell'Area 2.

Oggetto : FABBRICATI 1 - 4

## Piante - Sezioni

TAV. 01

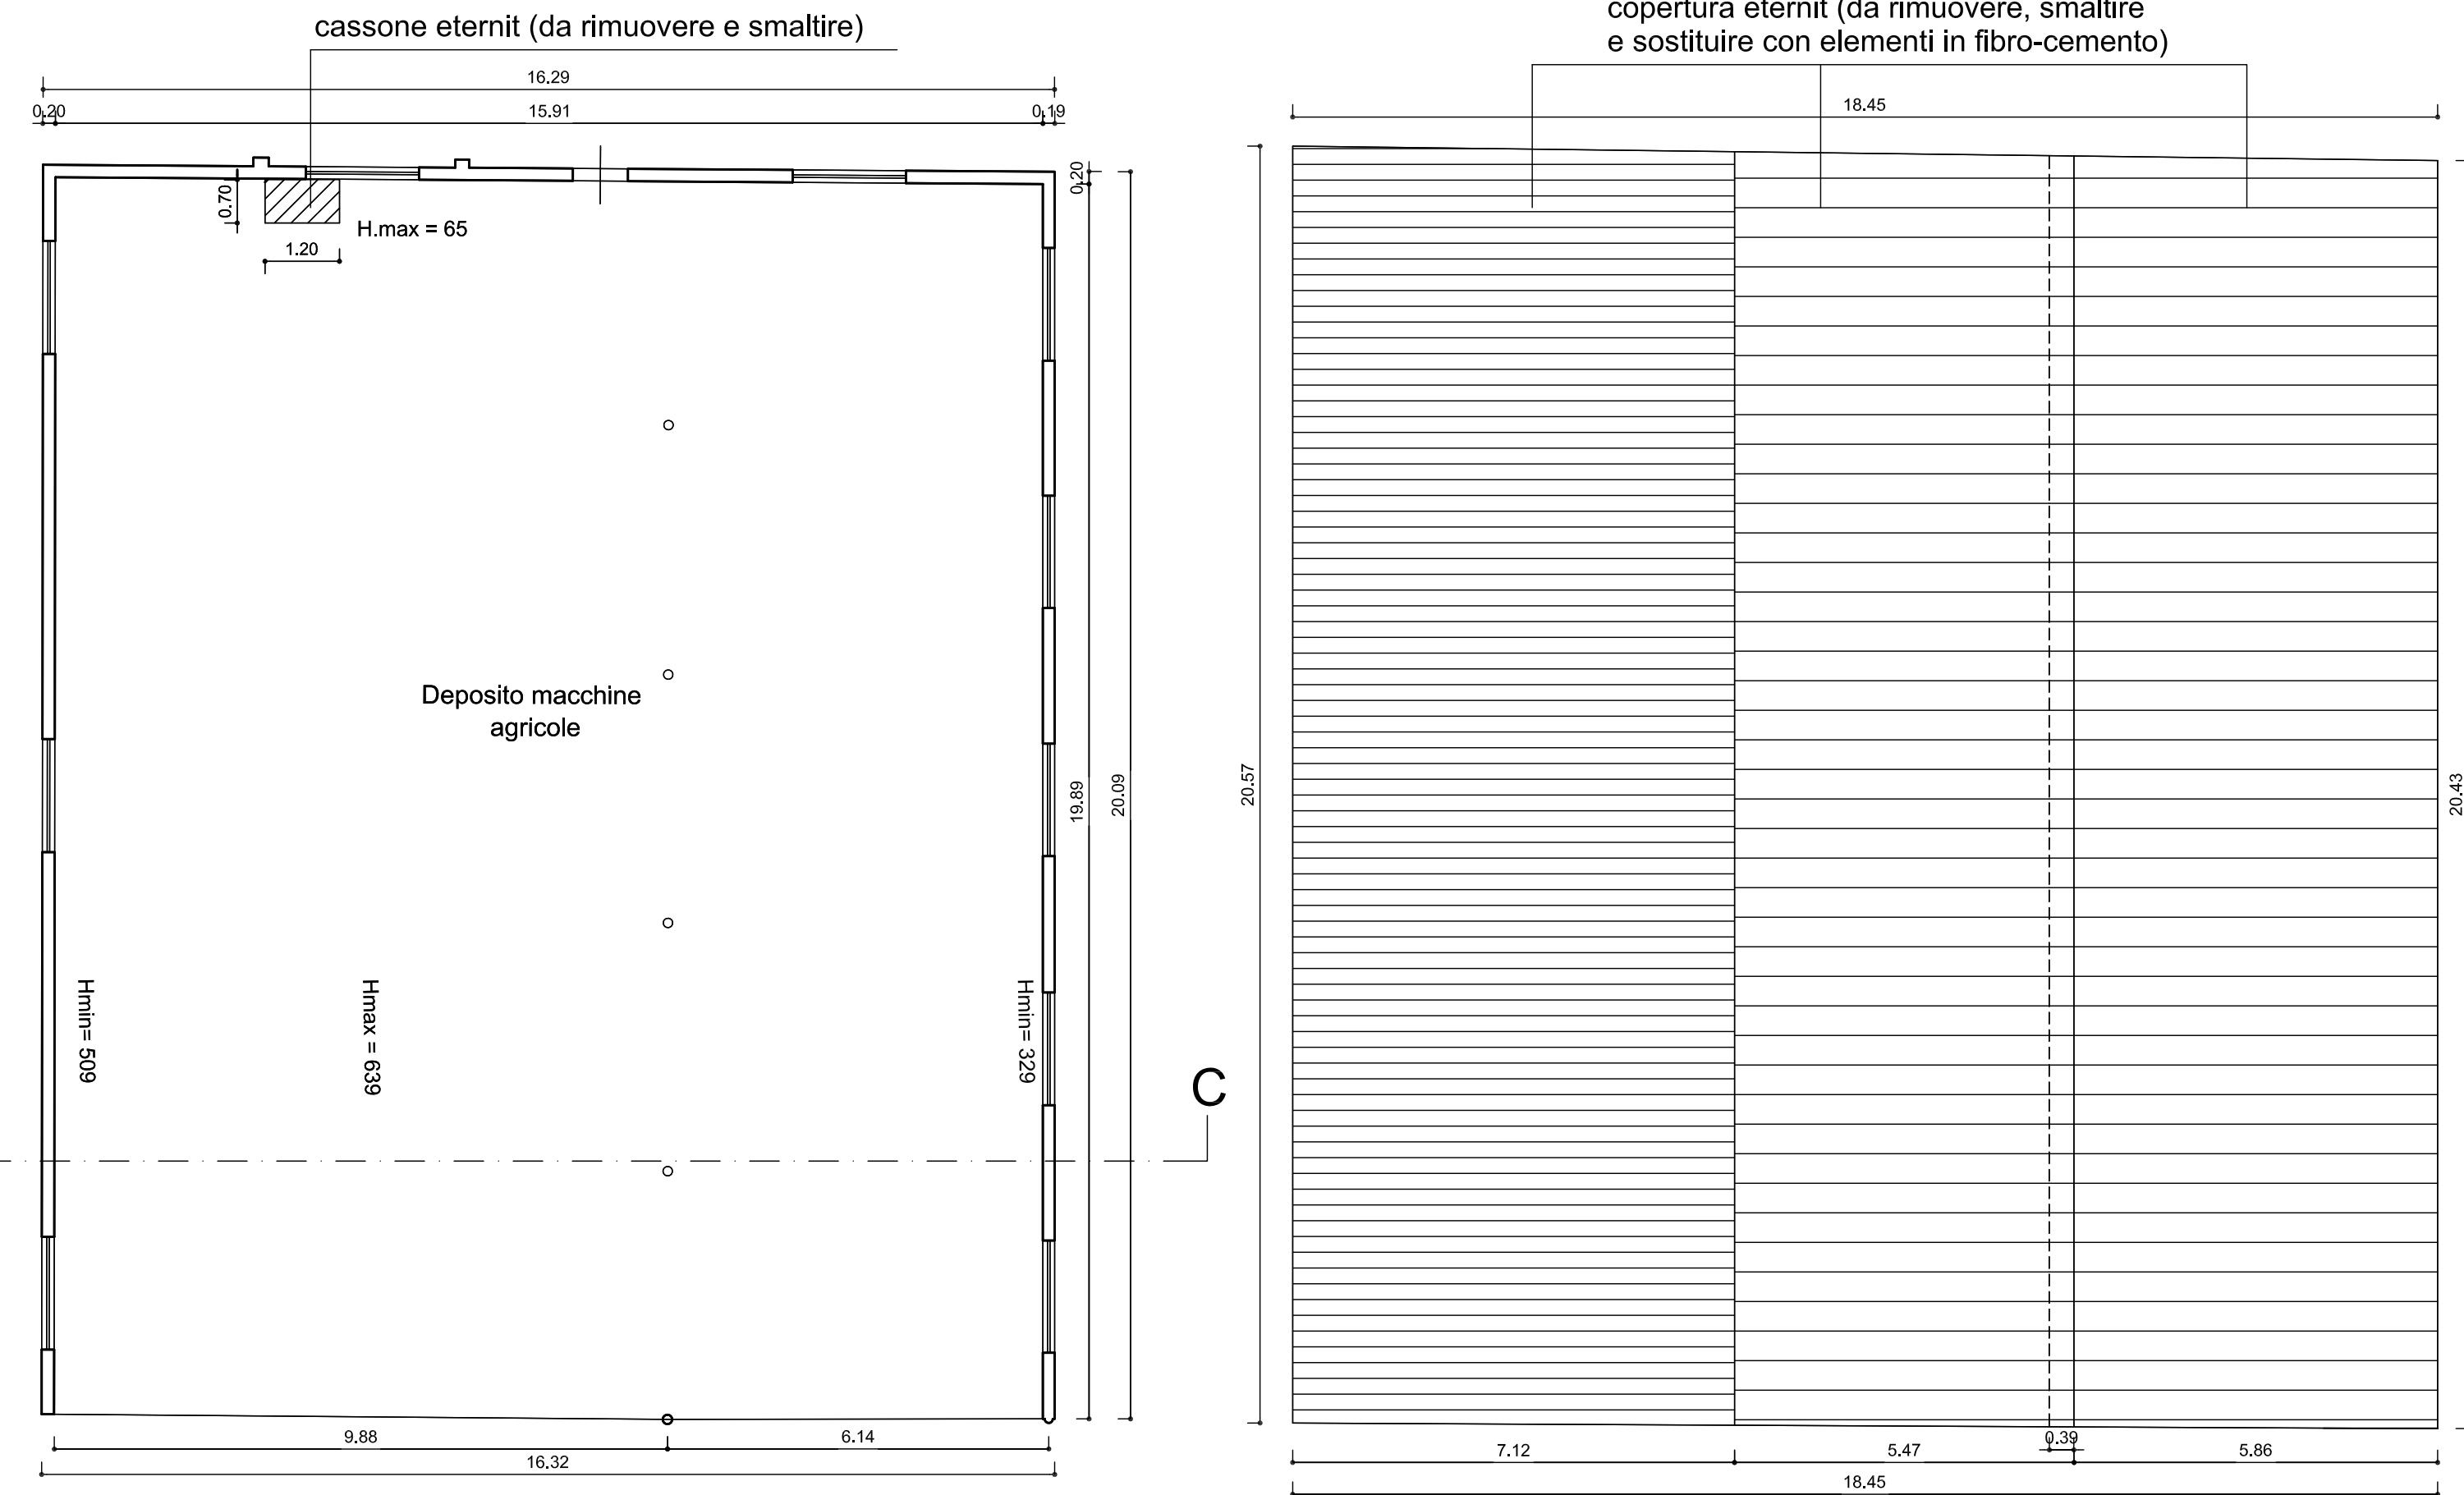
## FABBRICATO 1

copertura eternit (da rimuovere, smaltire e sostituire con elementi in fibro-cemento)
